Small Site Architecture of
Chaco Canyon
New Mexico

Peter J. McKenna
Marcia L. Truell

Publications in Archeology 18D
Chaco Canyon Studies

National Park Service
U.S. Department of the Interior

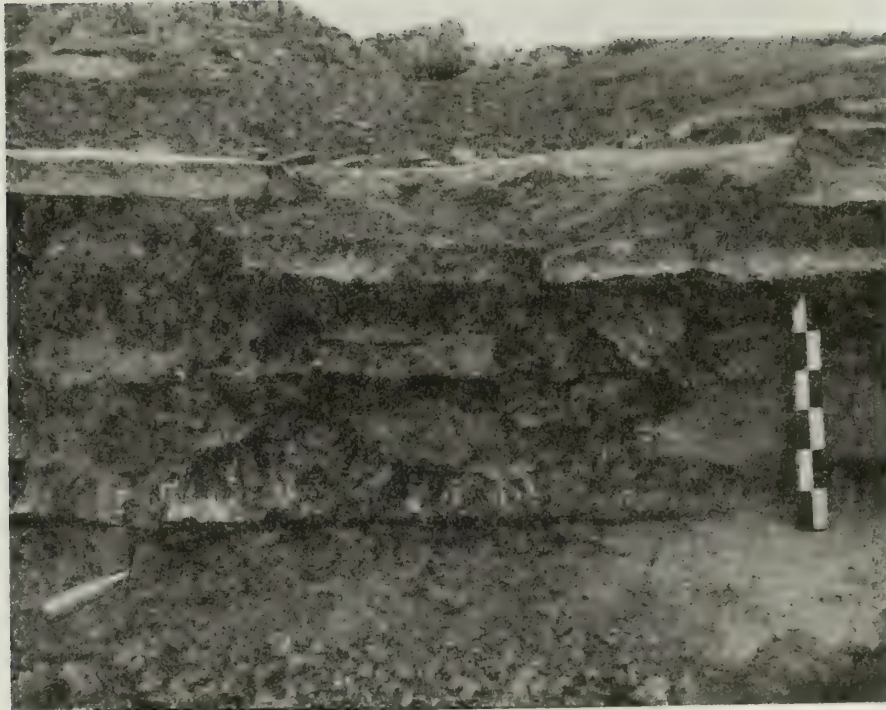
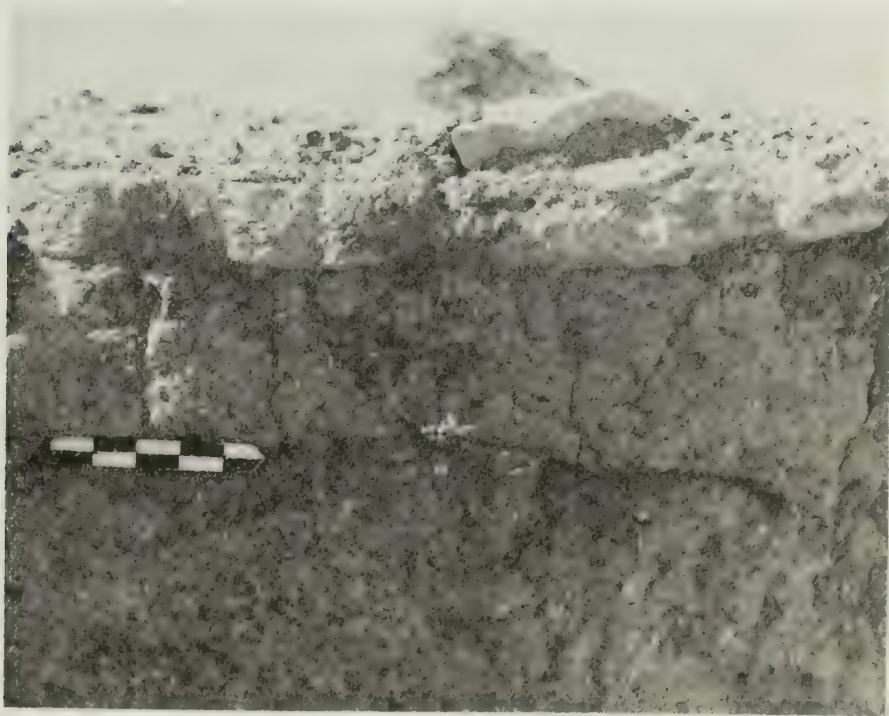
Figure 2.13. Adobe foundations beneath walls constructed in the late 900s-middle 1000s. (a) 29SJ 629, Room 8 (storage), west wall foundation; (b) 29SJ 1360, House 1, Room 4 (living room), north wall adobe foundation.

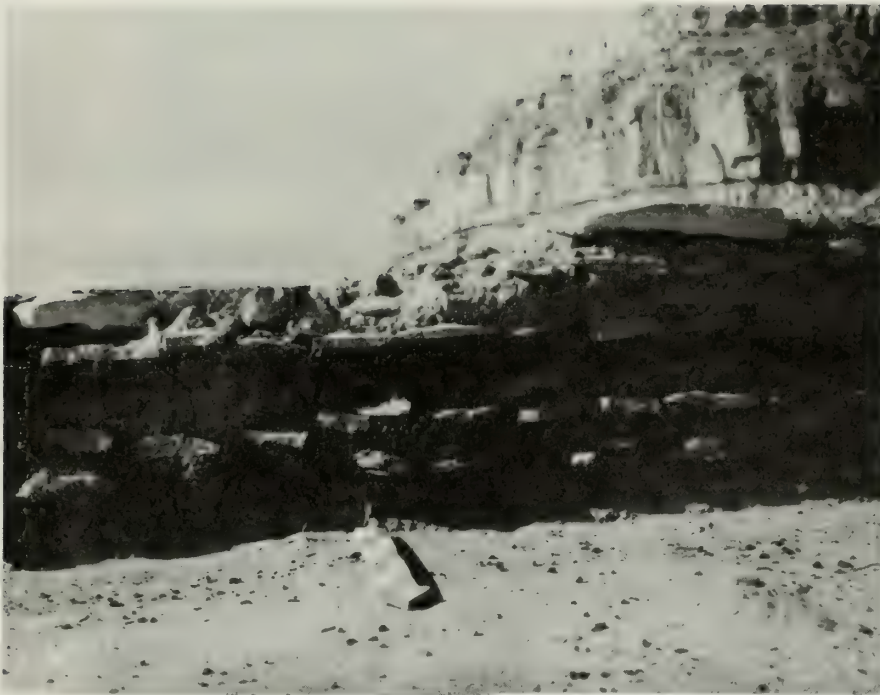
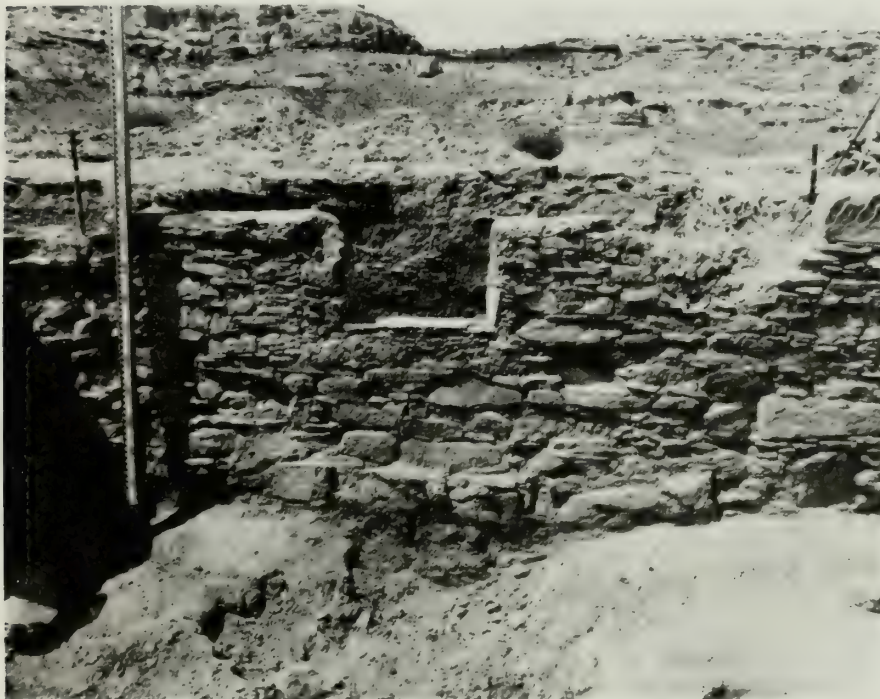
Figure 2.14. Examples of masonry from living and storage rooms built in the late A.D. 900s-middle 1000s. (a) 29SJ 1360, Room 8, south wall; (b) 29SJ 627, Room 8 (living room), west wall.

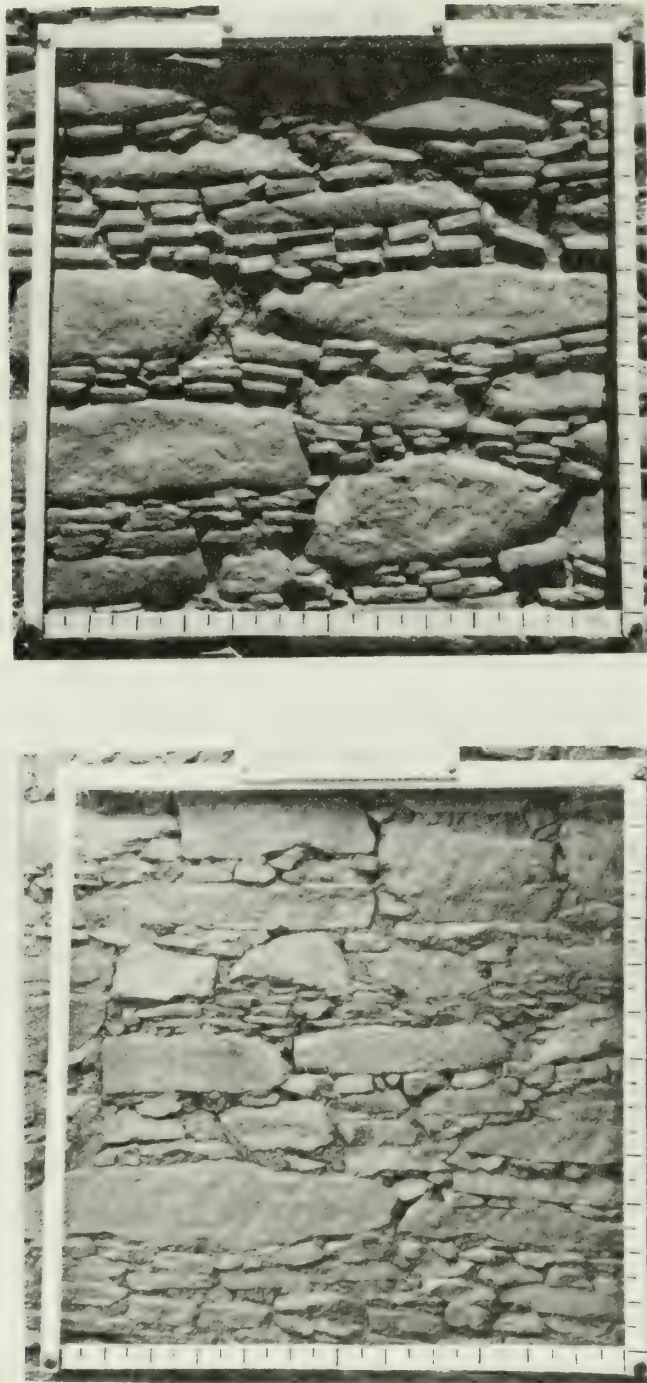
Figure 2.15. Examples of compound and simple masonry in room walls from the late A.D. 1000s-middle 1100s. (a) Bc 57, Room 2, north wall; (b) Bc 53, Room 4, north wall.

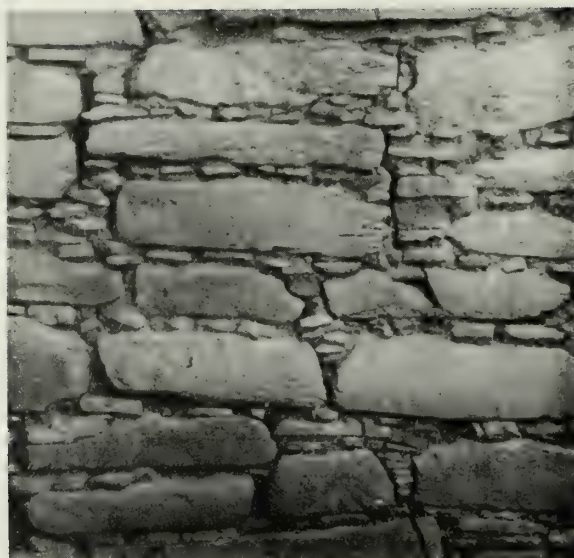
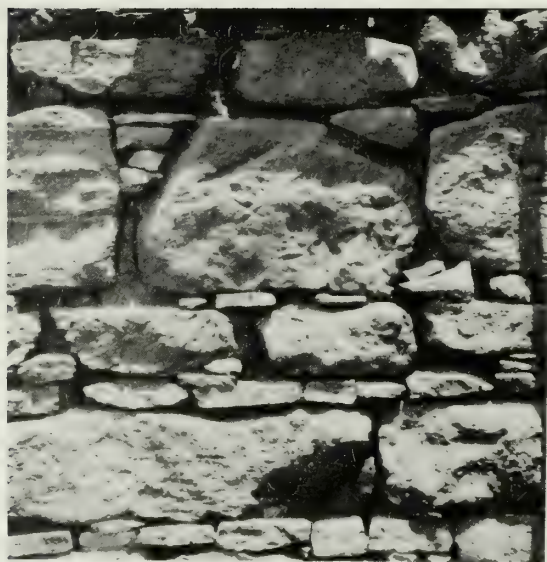
Figure 2.15 continued. (e) Bc 51, Room 2, west wall; (f) Leyit Kin (29SJ 750), Room 9, north wall.

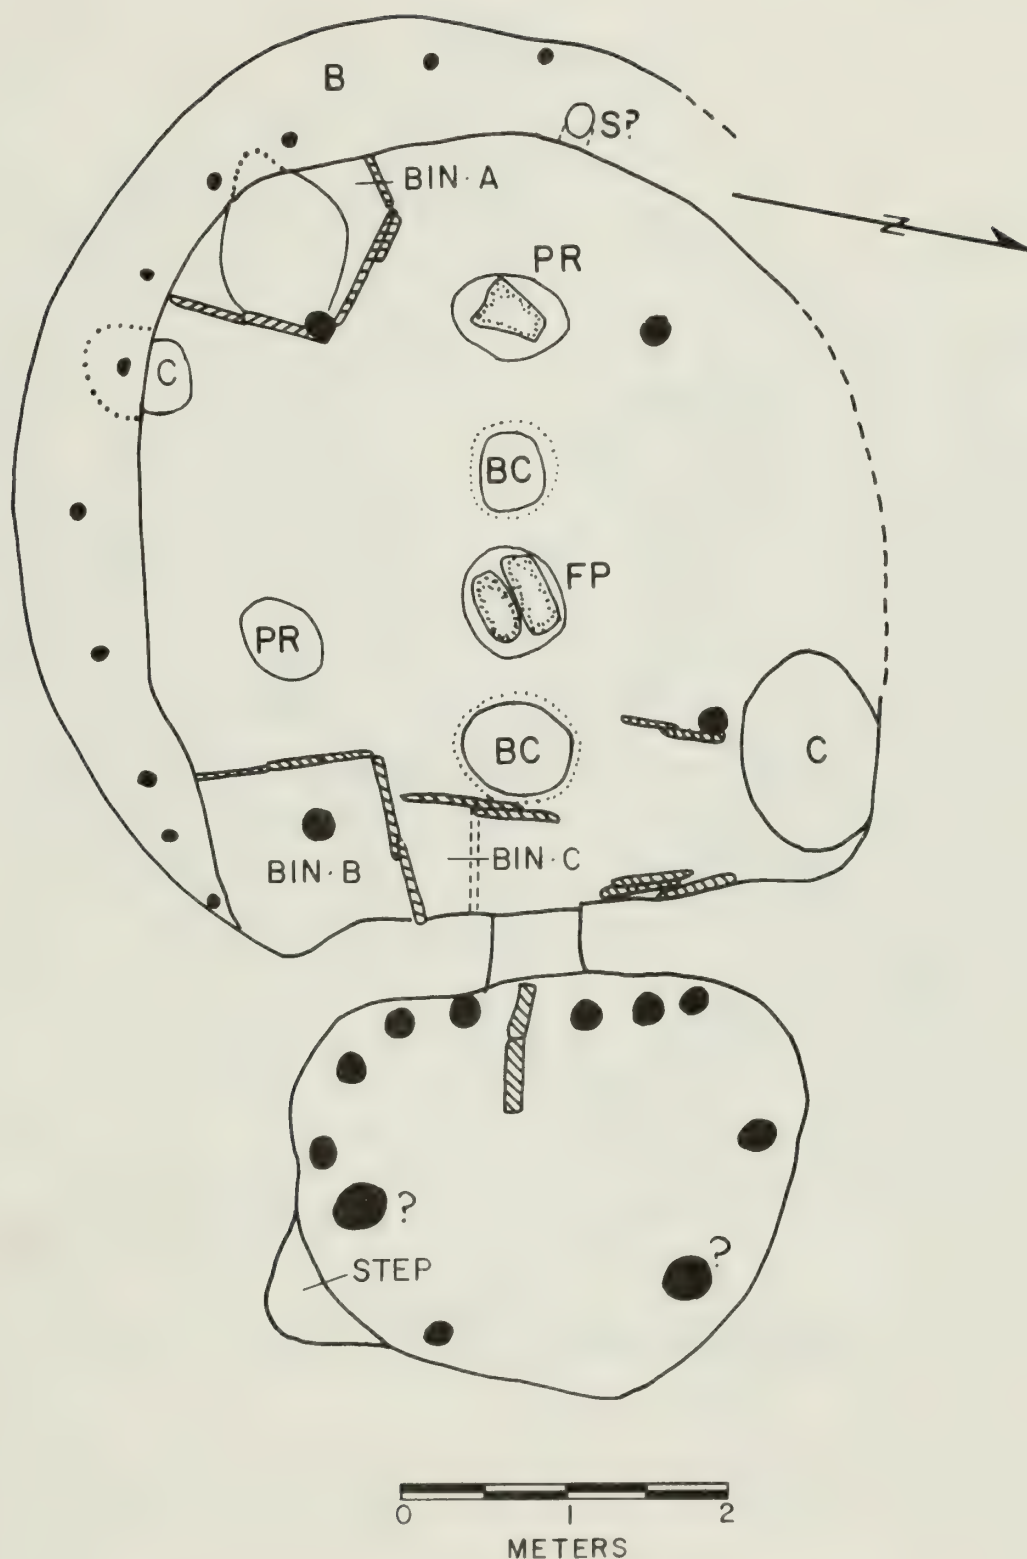
Figure A.1. Site 29SJ 299, Pithouse A (after Loose 1979).

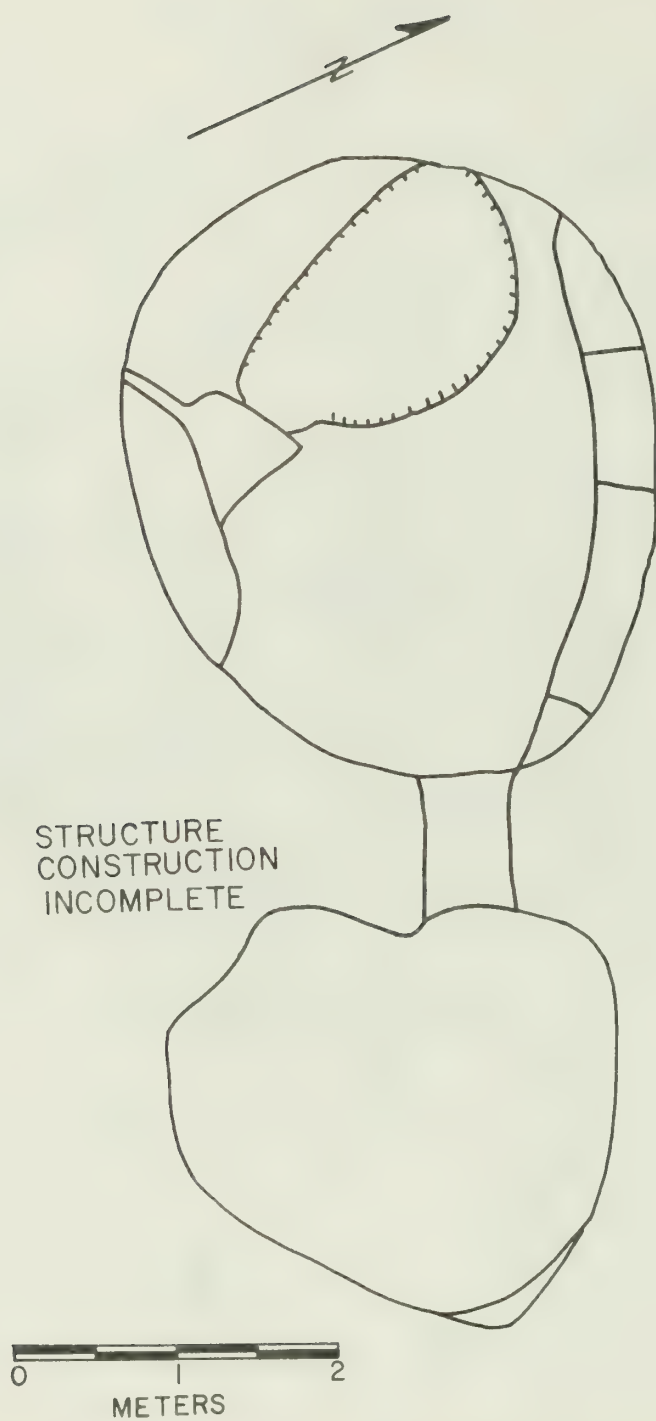
Figure A.2. Site 29SJ 299, Pithouse C (unfinished) (after Loose 1979).

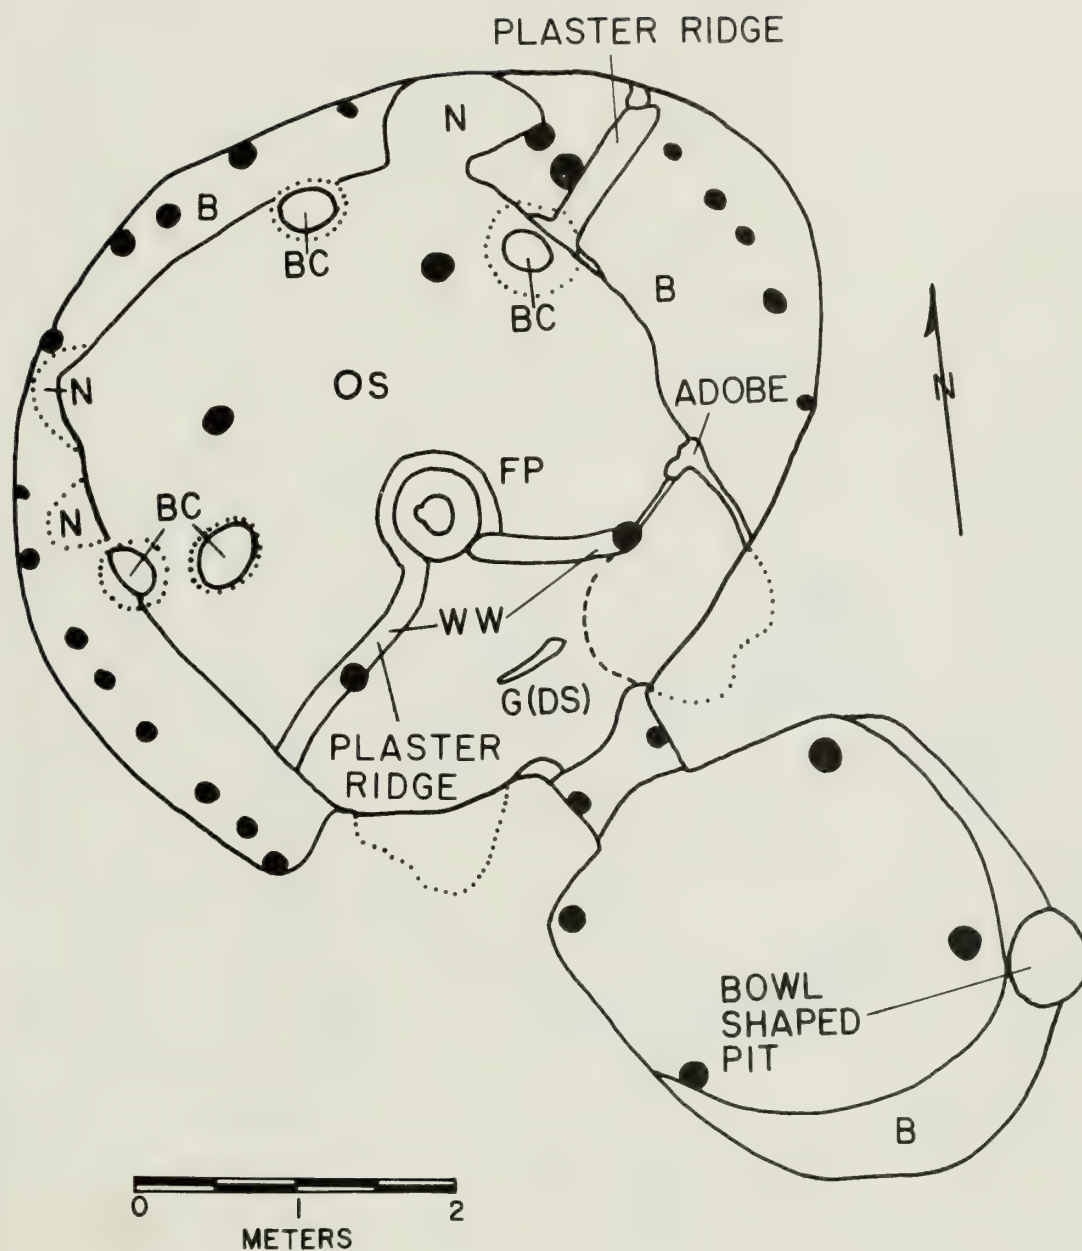
Figure A.3. Site 29SJ 299, Pithouse D (after Loose 1979).

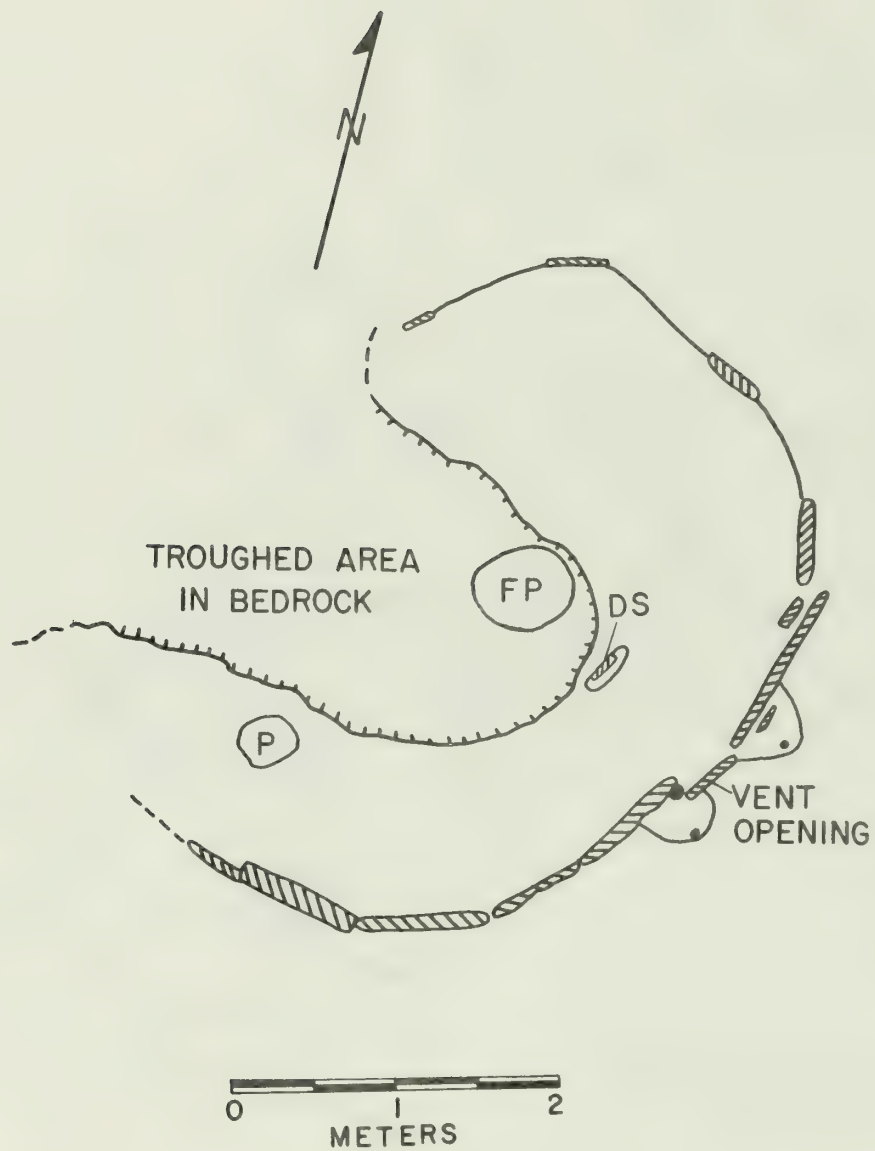
Figure A.4. Site 29SJ 423, Pithouse B (after Windes 1975a).

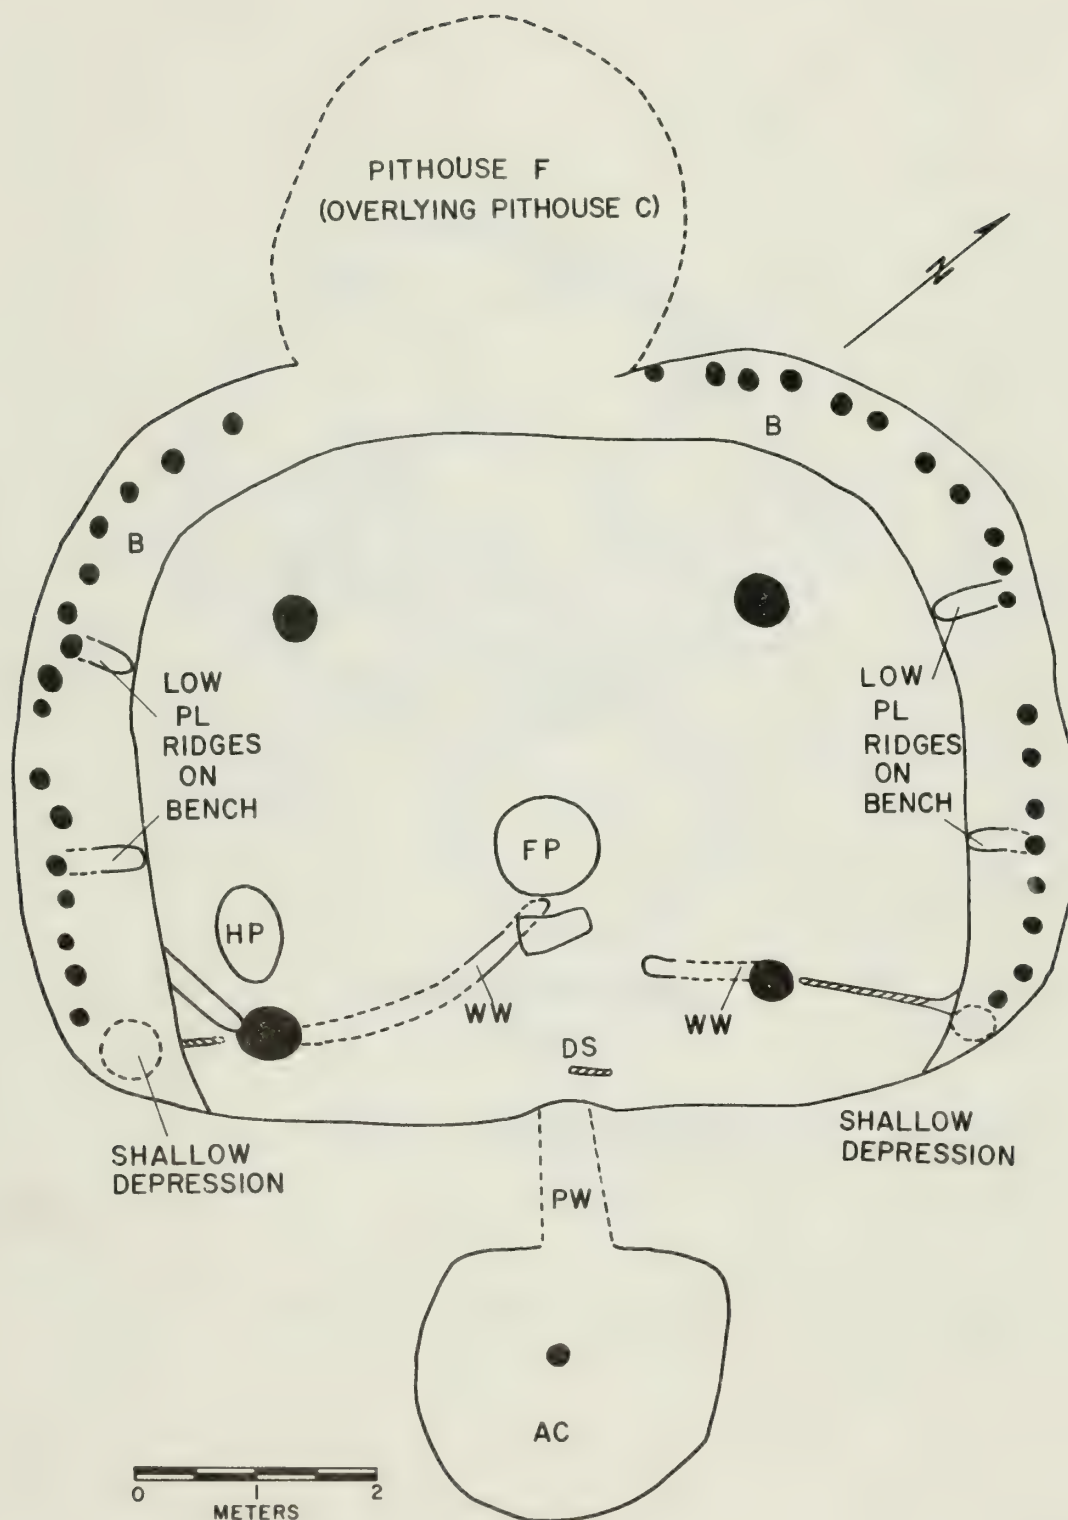
Figure A.5. Site 29SJ 628, Pithouse C (after Truell 1976).

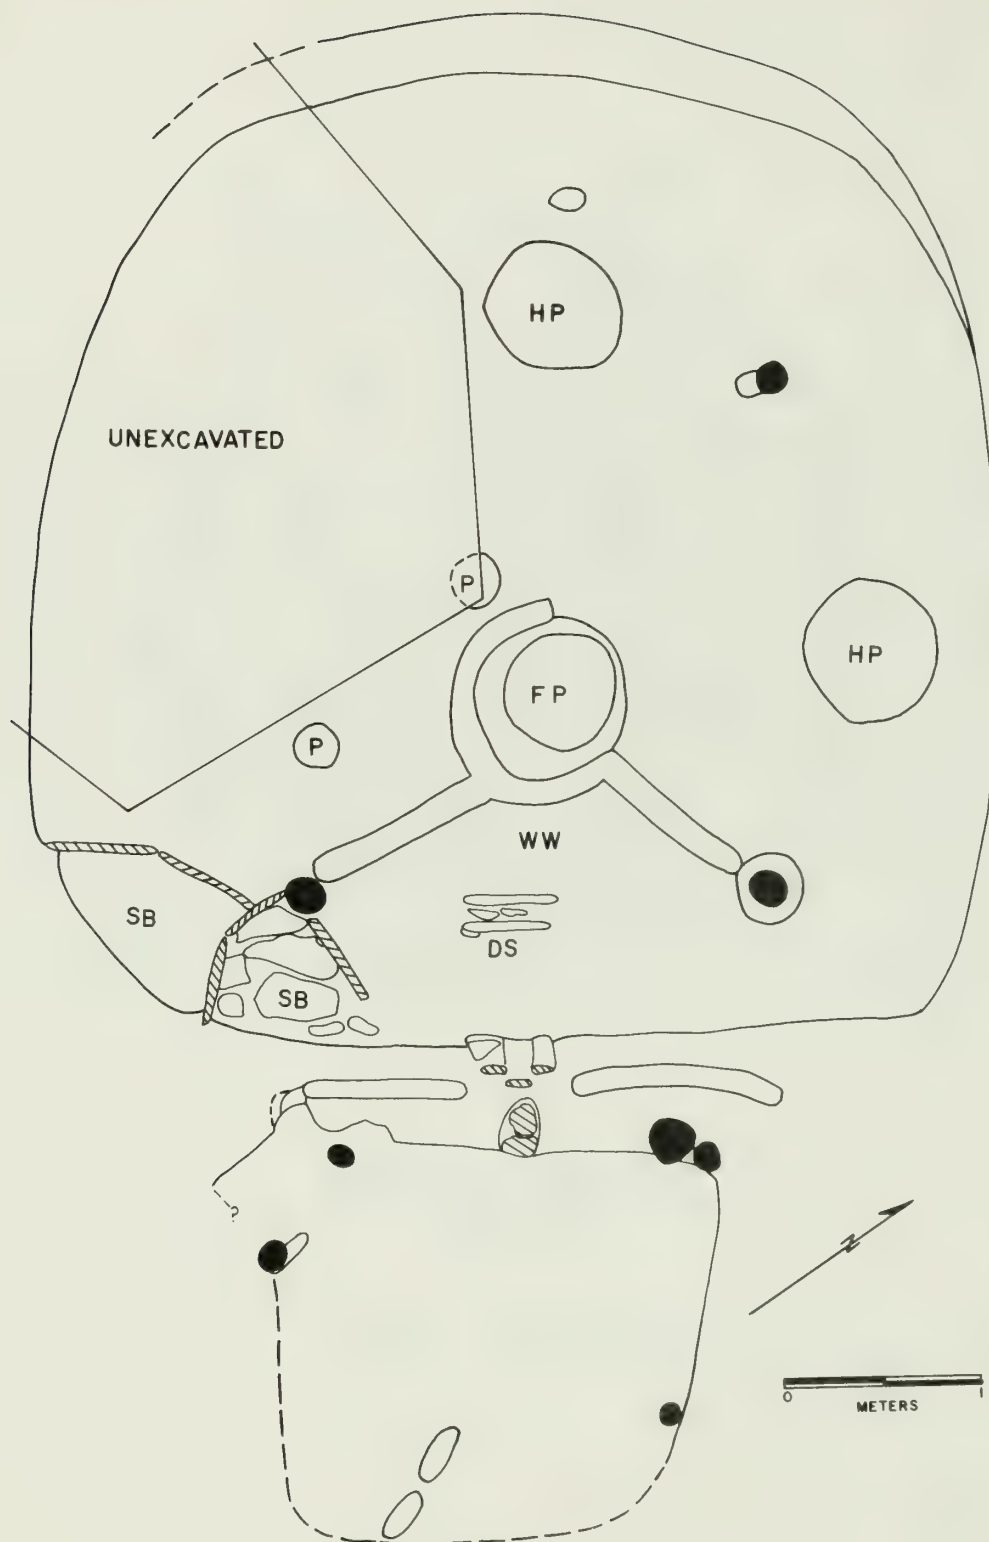
Figure A.24. Shabik'eshchee Village, Pithouse Y (after Hayes and Thrift 1973).

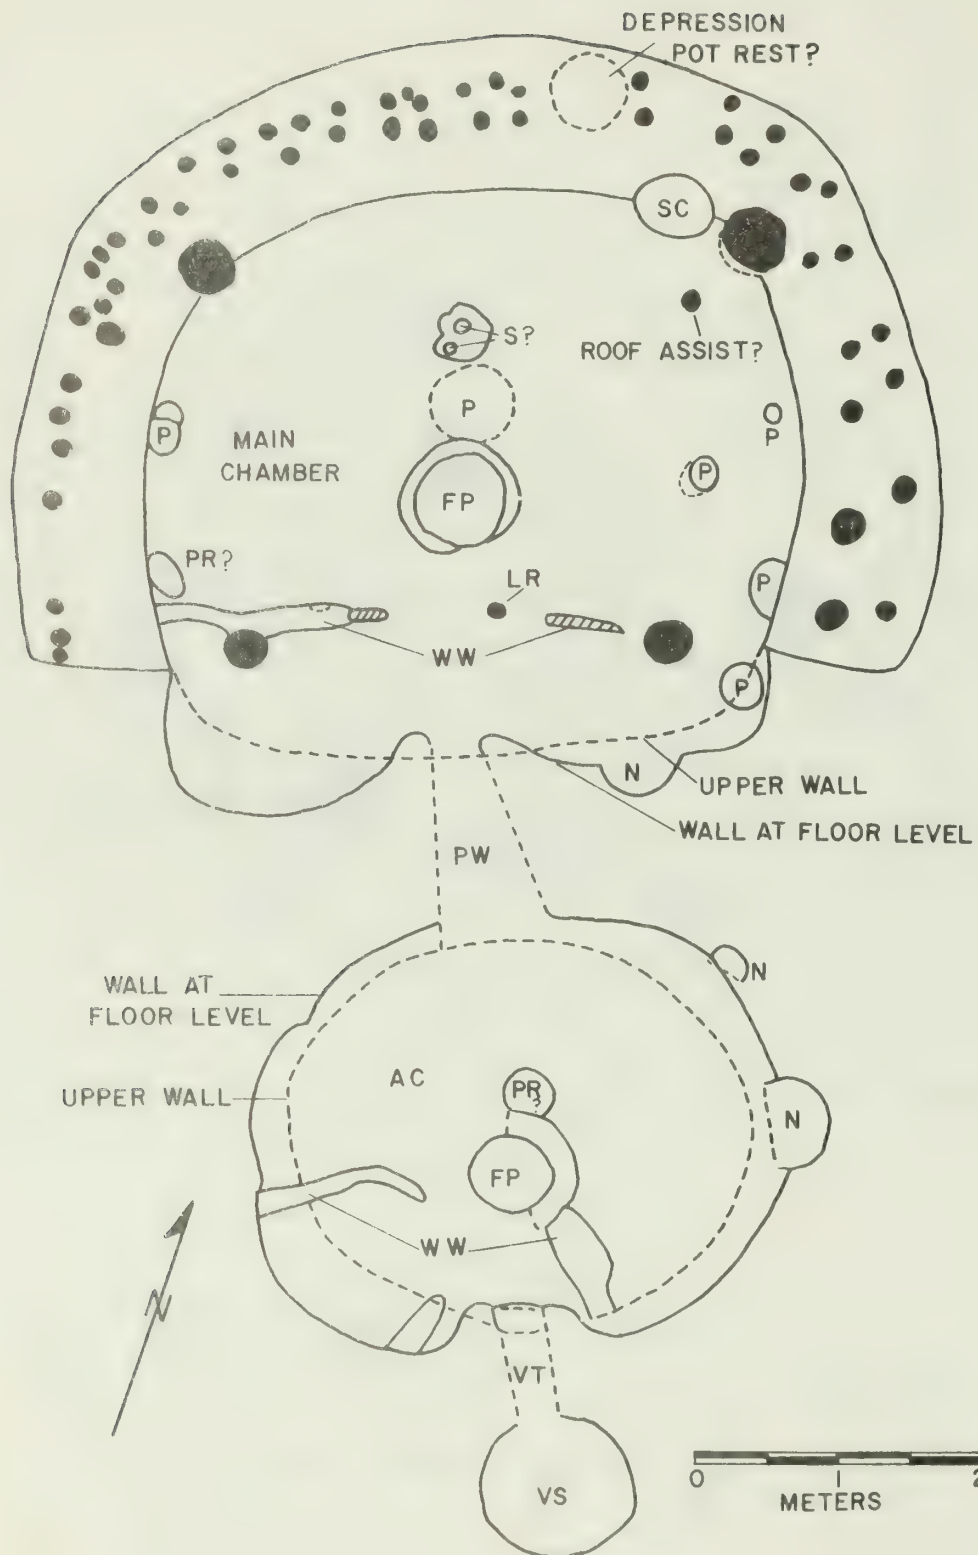
Figure A.28. Site 29SJ 628, Pithouse D (after Truell 1976).

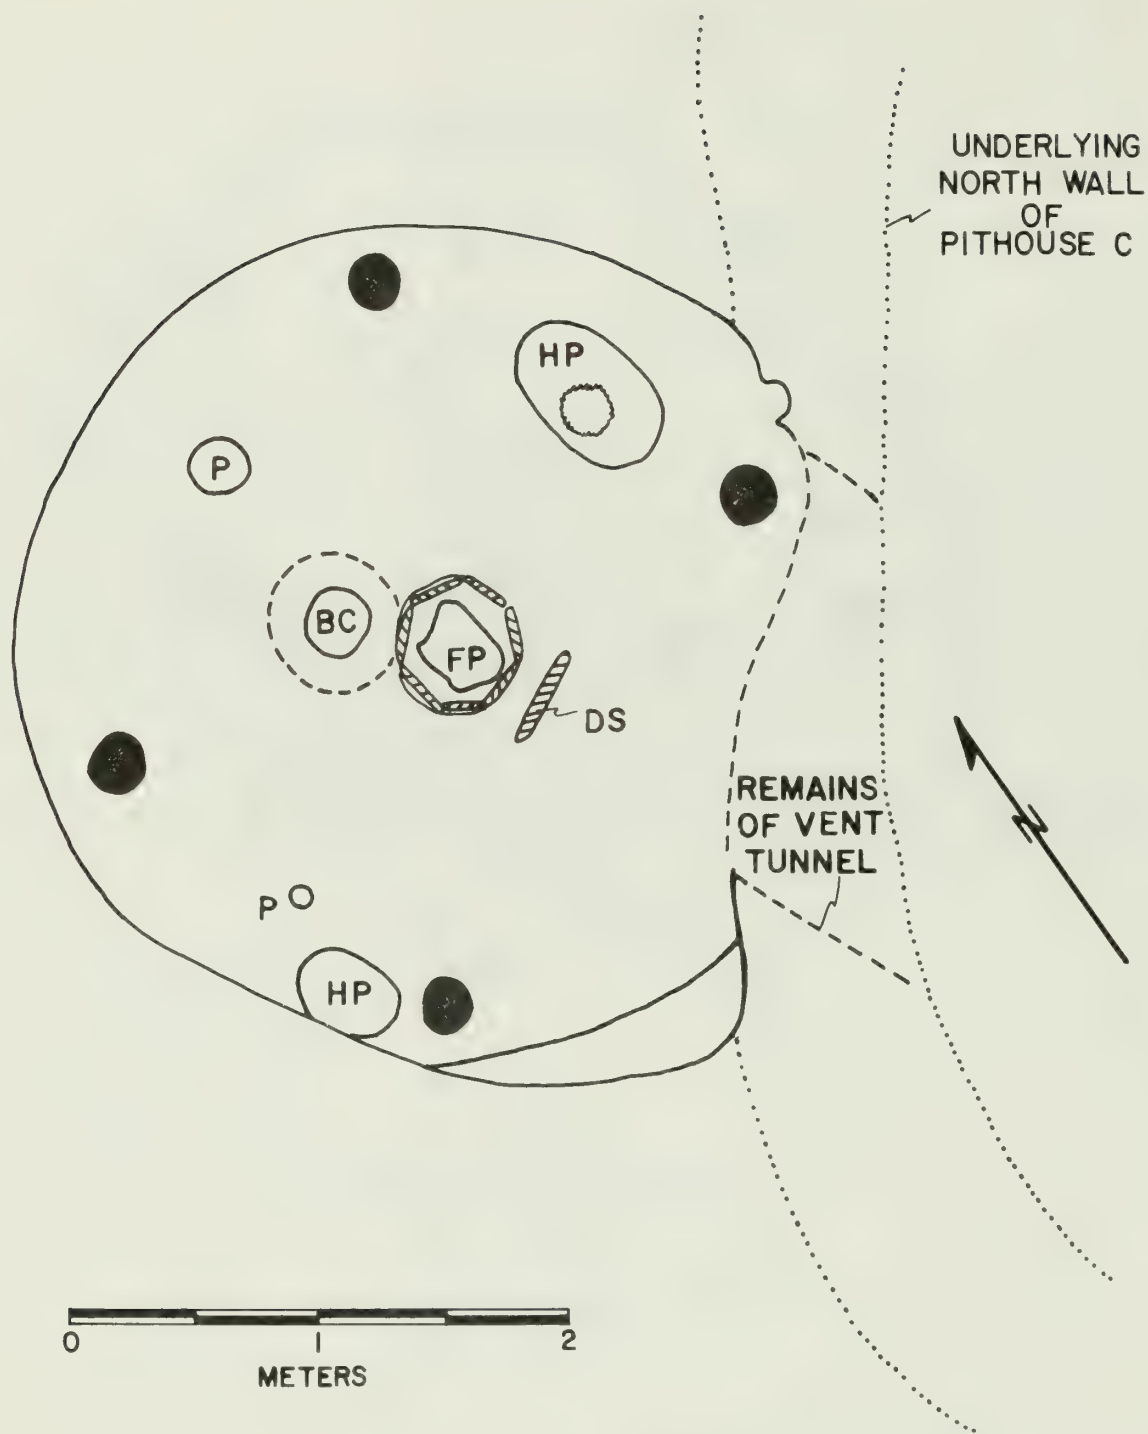
Figure A.30. Site 29SJ 628, Pithouse F (after Truell 1976).

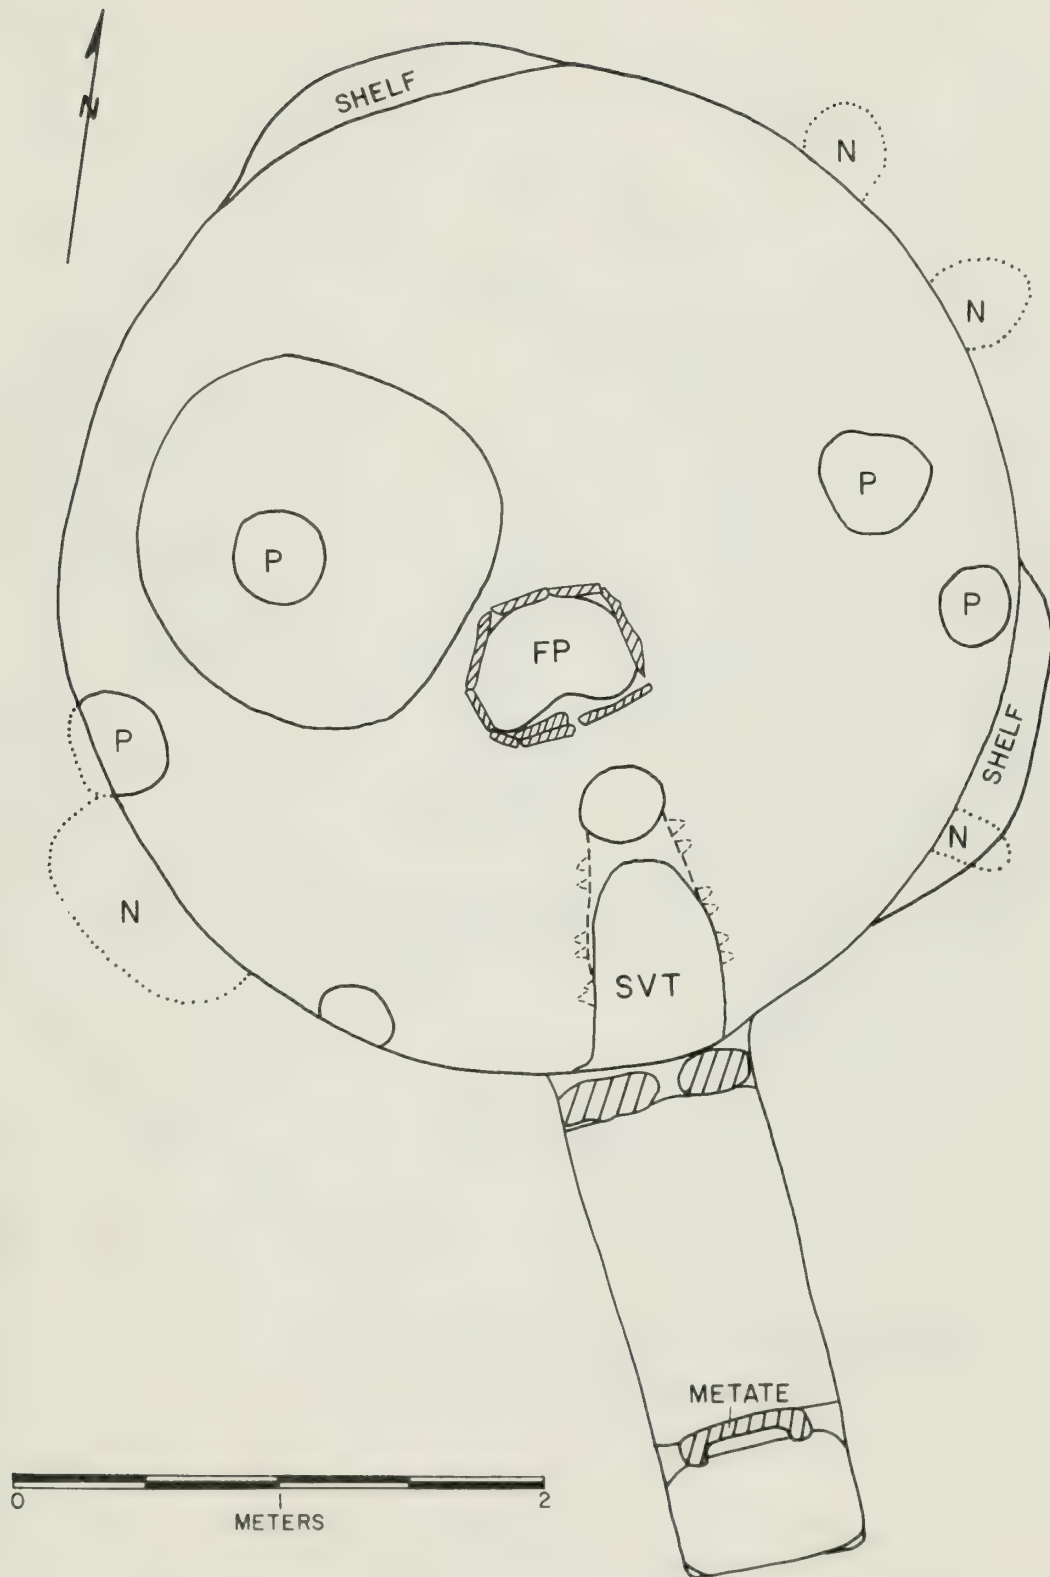
Figure A.43. Site 29SJ 299, Kiva B (after Loose 1979).

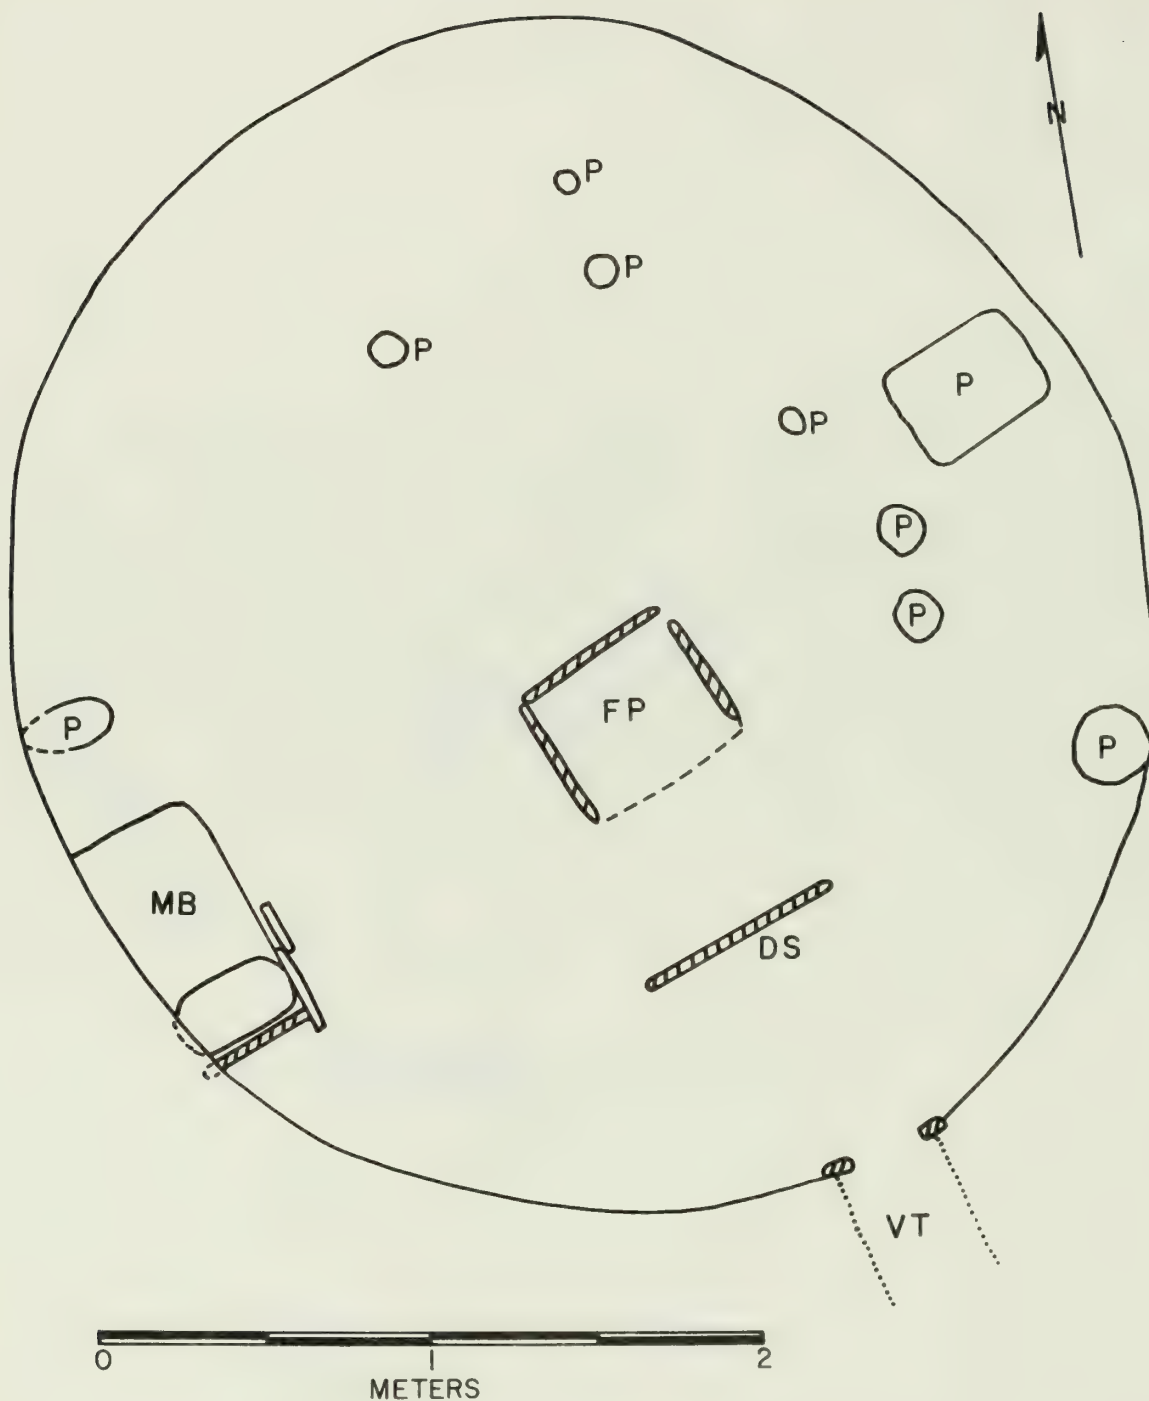
Figure A.44. Site 29SJ 627, Kiva D (after Truell 1981).

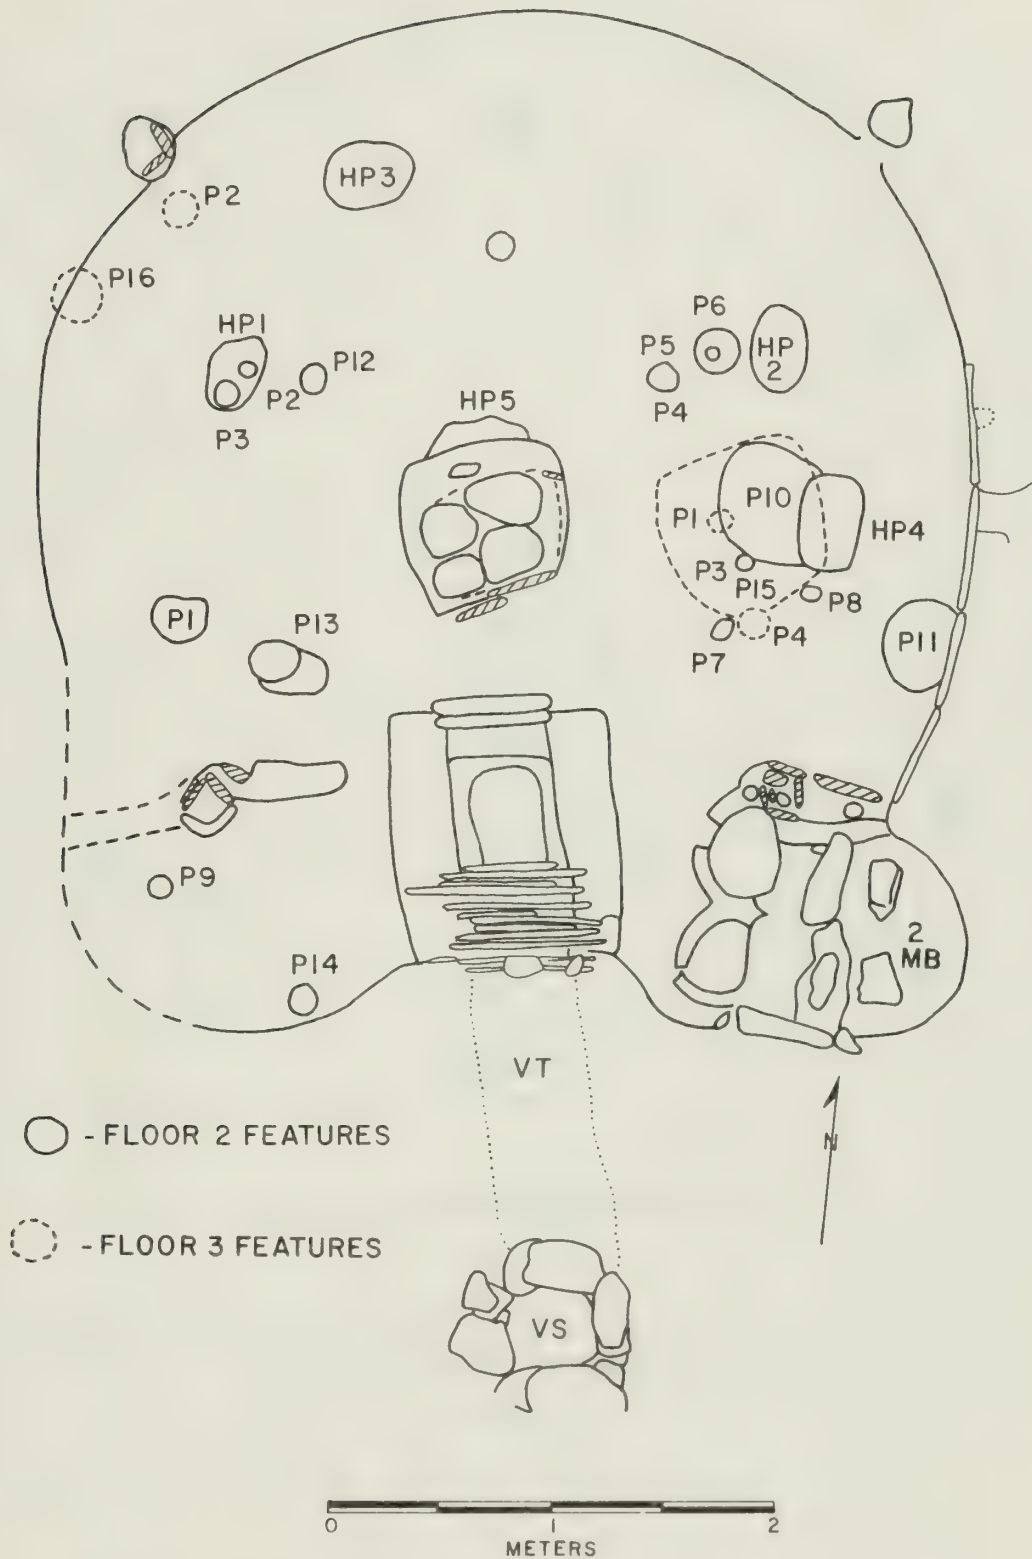
Figure A.47. Site 29SJ 629, Pithouse 2 (after Windes 1978).

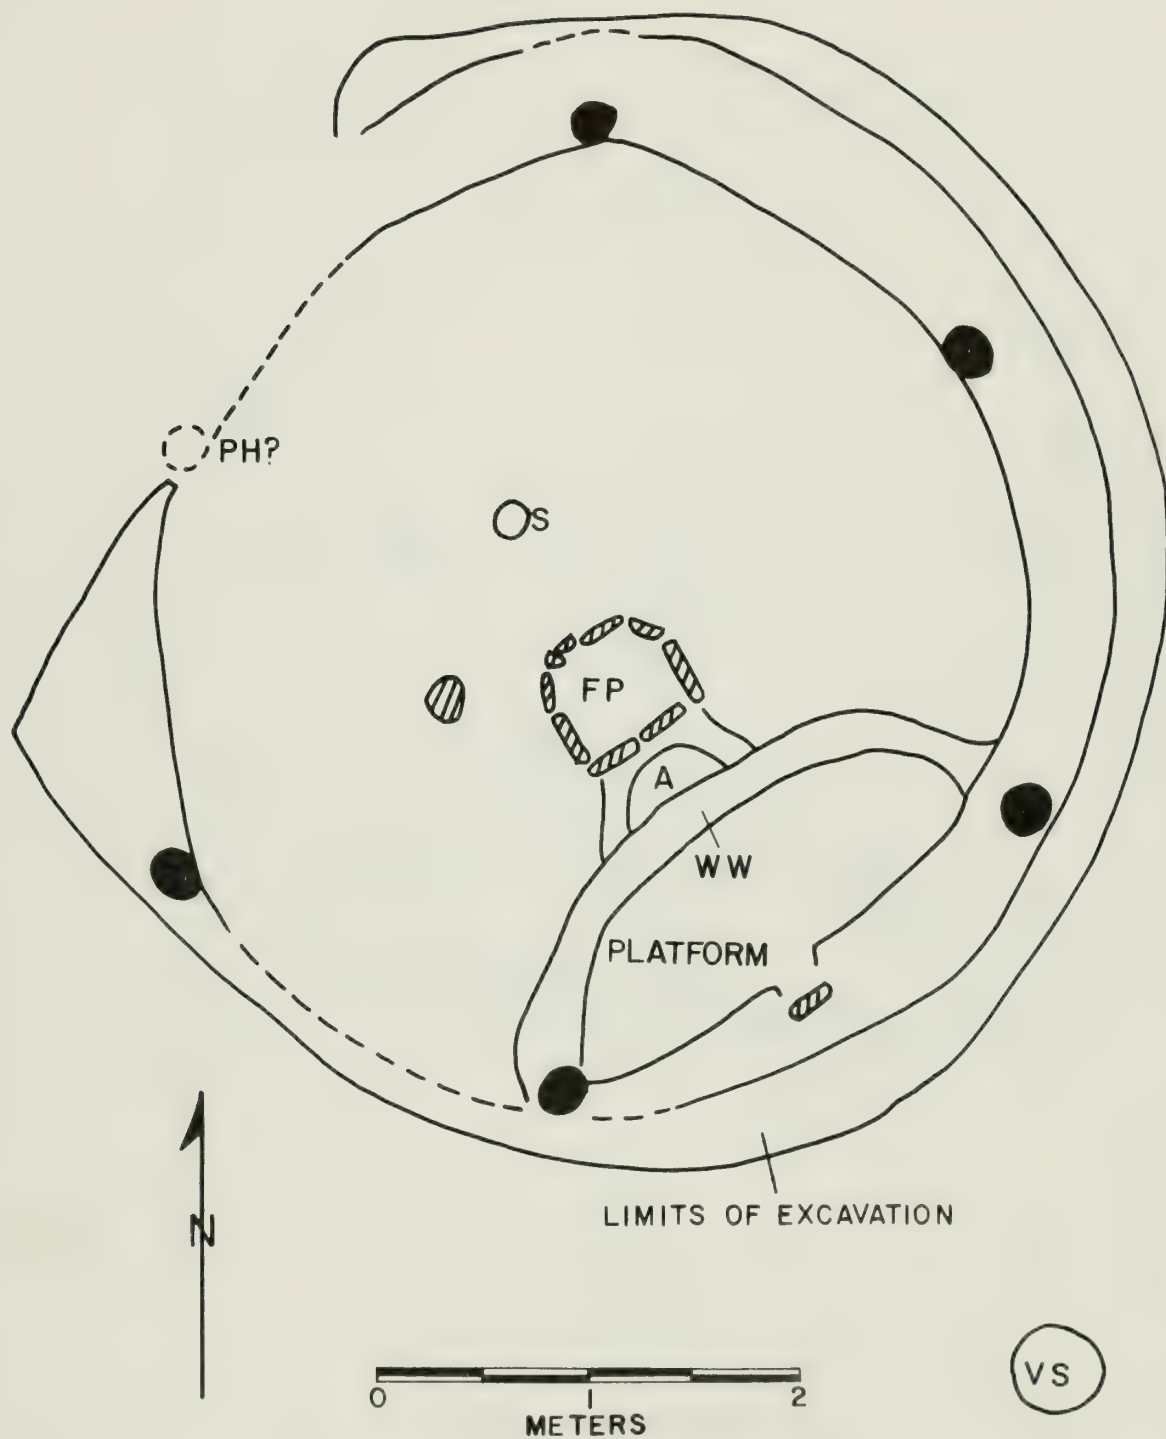
Figure A.49. Site 29SJ 1360, House 1, Kiva A (McKenna 1983).
